**Flood Control Project Maintenance
Levee Inspections**

Maintenance Issue Types Only, Levee Inspection Report By Mile - Fall 2019

Reclamation District No. 1602 Del Puerto

Waterway	Bank	Unit Miles	Inspection Start/End	Inspector
Unit No. 01 San Joaquin River	Left	6.24	11/06/2019 11/06/2019	Corey Fujitani

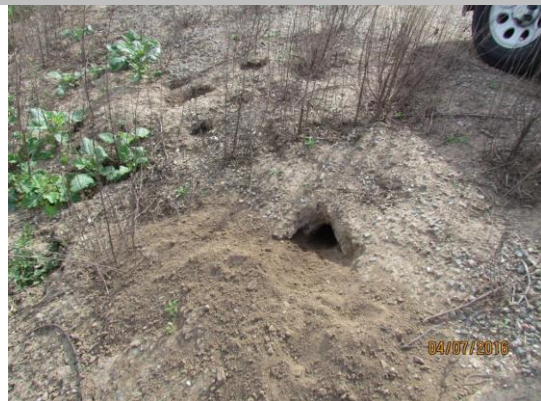
Photo 1 of 2 : FA_2019_RD1602_110_28_20190912_00008.jpg

Updated picture of the rodent hole on the waterside of the levee during spring 2016 inspection.

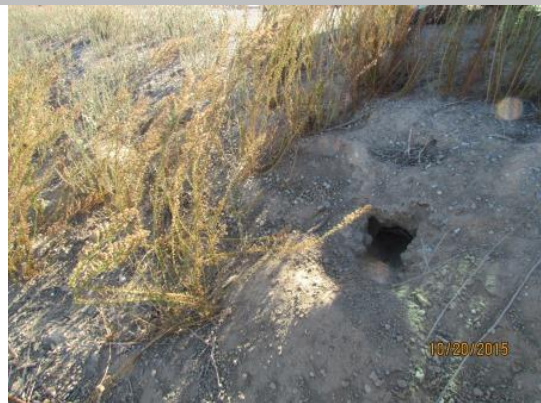
Photo 2 of 2 : FA_2019_RD1602_110_28_20190912_00009.jpg

A rodent hole was found on the waterside of the levee.

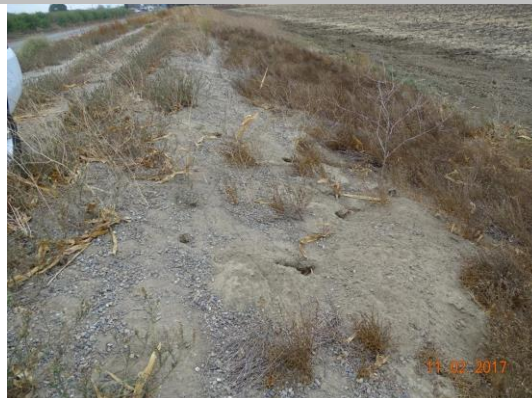
Photo 1 of 2 : FA_2019_RD1602_110_29_20190912_00010.jpg

View of a rodent hole on the waterside of the levee. Fall 2017

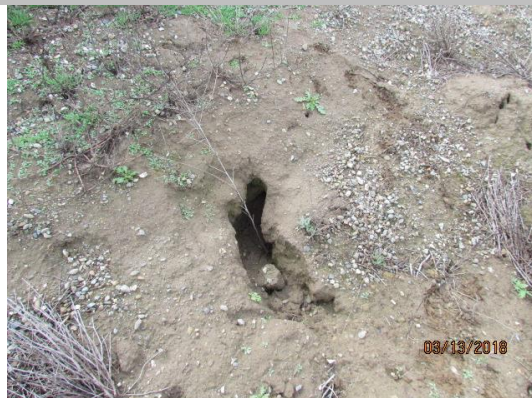
Photo 2 of 2 : FA_2019_RD1602_110_29_20190912_00011.jpg

Looking at typical rodent holes on waterward slope. (Spring 2018)

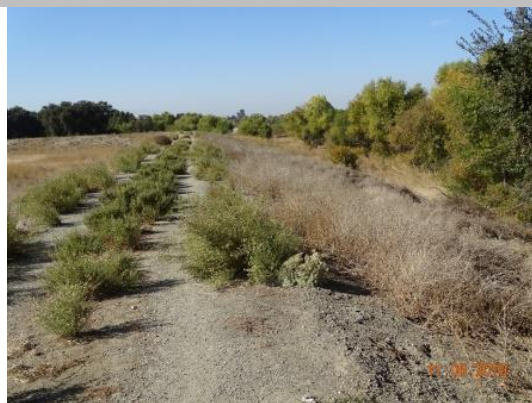
Photo 1 of 1 : FA_2019_RD1602_110_124_20191114_00107.jpg

View of the waterside slope looking downstream. (Fall 2019)

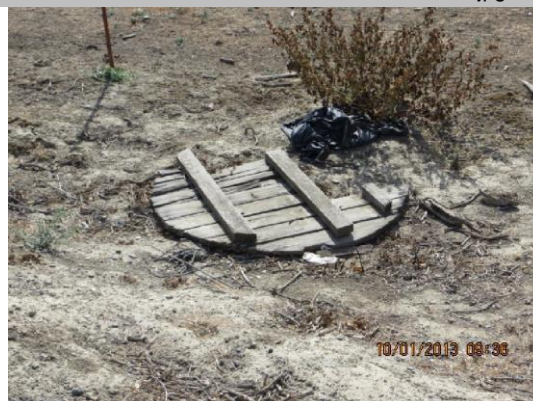
Photo 3 of 3 : UCIP_FA_2019_51325_36700.jpg

Damaged Wooden lid on WS toe.

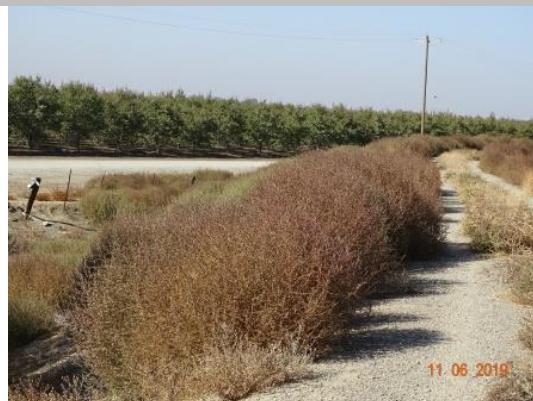
Photo 1 of 1 : FA_2019_RD1602_110_129_20191114_00111.jpg

LM Start	0.60	Rating **	U	Issue No.	129
LM End	0.76	Issue Type +	Ma	Location *	LS
Category	Earthen Levee			GPS Latitude/Longitude	
				Start	End
Item	Vegetation			37.479970 °	37.478111 °
				-121.074599 °	-121.072783 °
DWR ID	DWR_RD1602_01_f_2019_129				
Comment Code					
V1 : Control annual grass and weeds on the levee slopes and easements.					
Inspector Comment

View of the vegetation along the landside slope looking downstream.
(Fall 2019)

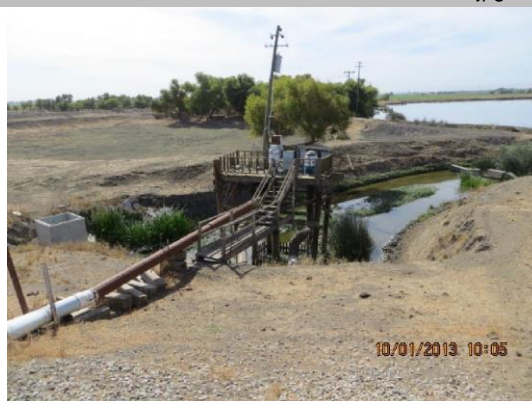
Photo 1 of 3 : UCIP_FA_2019_51636_36758.jpg

Comment Code					
Inspector Comment					
DS_ID:20217 FS_ID:51636 EP_NO: N/A Repair Type: Non-Urgent Crossing Status: Found UCIP Comments: 11/18/2016 Crossing has been downgraded from Urgent to Non-Urgent a flap gate has been added to the WS but pipe is currently not connected to pump. According to Tony Martinez, LMA representative, this crossing is currently not in use. Owner will need to coordinate with CVFPB to obtain permit. (O. Magana - DWR UCIP)10/01/2013 Appears abandoned and if so should be done so properly. Flapgate missing. (W. Wylie - DWR UCIP) FIELD_STRUCT_DESC: *ABANDONED* 1 of 2: 16-inch steel drainage pipe through levee, 17 feet below crown. Pumps on the pump platform are located on the landside (LS). Siphon breaker in 24-inch corrugated metal pipe (CMP) riser is located on the waterside (WS) shoulder. Concrete "U" headwall and flap gate are located on the WS end. [Additional Reference(s): DWR Levee Log, 1992. USACE San Joaquin River O&M Manual Unit 13, April 1964, (HLM 1.01), Drawing No. 7-4-1784]. FS Date: 11/18/2016

Pumping plant on LS toe. Pipe visible under walkway.

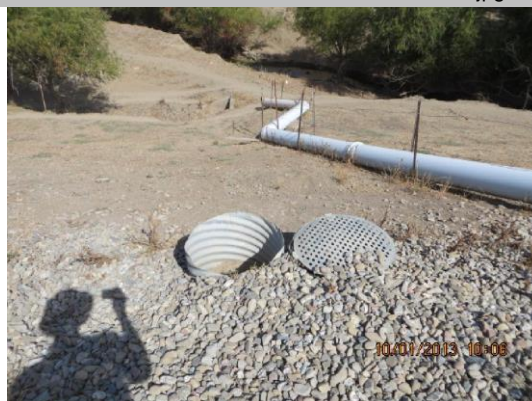
Photo 2 of 3 : UCIP_FA_2019_51636_36757.jpg

Siphon breaker in 24-inch CMP riser on WS shoulder.

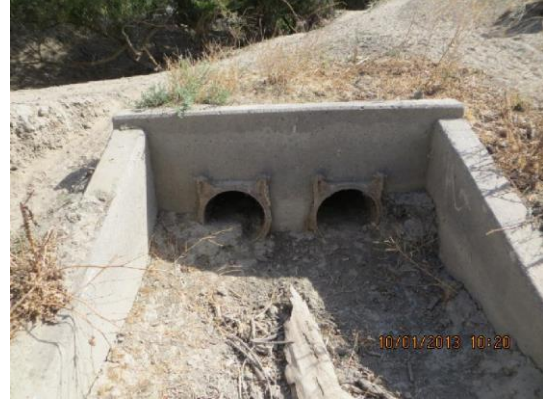
Photo 3 of 3 : UCIP_FA_2019_51637_36770.jpg

Concrete headwall on WS toe with missing flapgate.

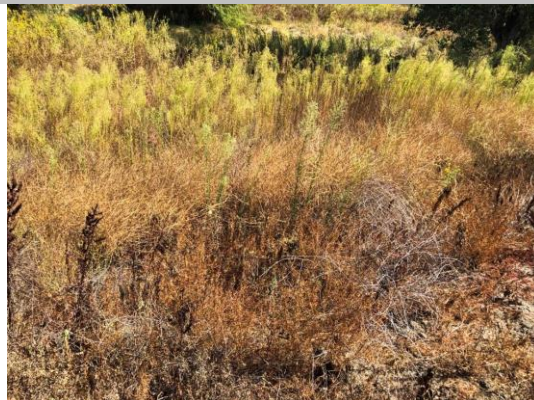
Photo 1 of 3 : SJR2019_DWR_RD1602_01_s _ 2012_37_1.jpg

LM Start	1.05	Rating **	M	Issue No.	2
LM End	1.05	Issue Type +	Ma	Location *	
Category	Supplemental			GPS Latitude/Longitude	
				Start	End
Item	DWR Erosion Survey			37.478567 °	37.478567 °
				-121.067847 °	-121.067847 °
DWR ID	RD1602U01RM97.68				
Comment Code					
Inspector Comment					
Site ID: RD1602U01RM97.68					
09/17/2019: No significant change observed. Signs of animal activities at the site.					
09/20/2017: The erosion was discovered during the spring levee inspection. The size of the erosion is roughly estimated due to dense vegetation at the site.

Close-up view of the erosion. The erosion is covered by dense vegetation at the site.

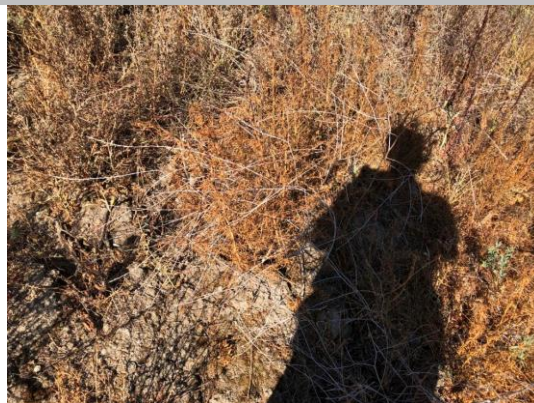
Photo 2 of 3 : SJR2019_DWR_RD1602_01_s _ 2012_37_4.JPG

Close view of the erosion.

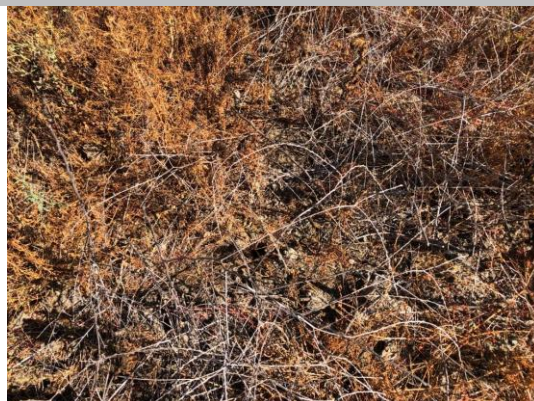
Photo 3 of 3 : SJR2019_DWR_RD1602_01_s _ 2012_37_8.JPG

Close-up view at the erosion. Signs of squirrel activities.

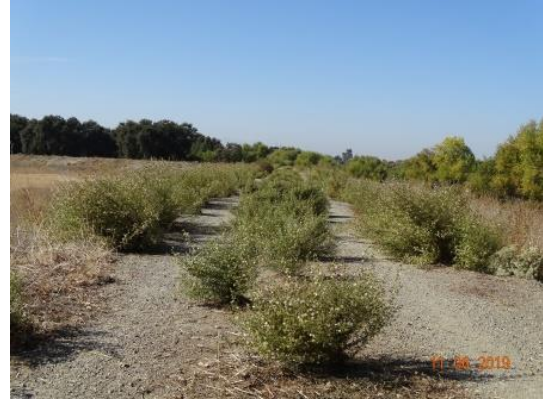
Photo 1 of 1 : FA_2019_RD1602_110_123_20191114_00114.jpg

View of vegetation on the levee crown. (Fall 2019)

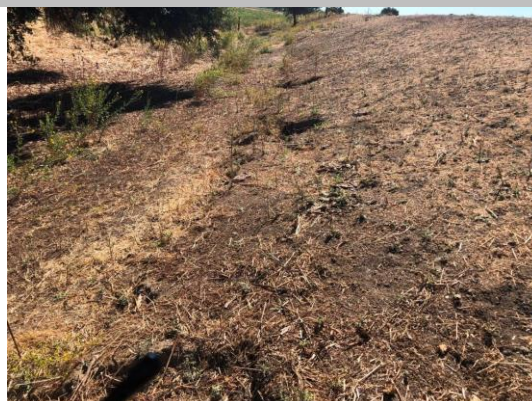
Photo 1 of 3 : SJR2019_DWR_RD1602_01_f _ 2018_98_1.JPG

LM Start	2.77	Rating **	M	Issue No.	19
LM End	2.79	Issue Type +	Ma	Location *	
Category	Supplemental			GPS Latitude/Longitude	
				Start	End
Item	DWR Erosion Survey			37.466997 °	37.466997 °
				-121.046606 °	-121.046606 °
DWR ID	RD1602U01RM99.7				
Comment Code					
Inspector Comment					
Site ID: RD1602U01RM99.7					
09/12/2019: Five erosion pockets were found in a reach of approximately 120 ft at the levee toe. The largest pocket is approximately 5 ft long and 3 ft high.

Looking down at the erosion pocket.

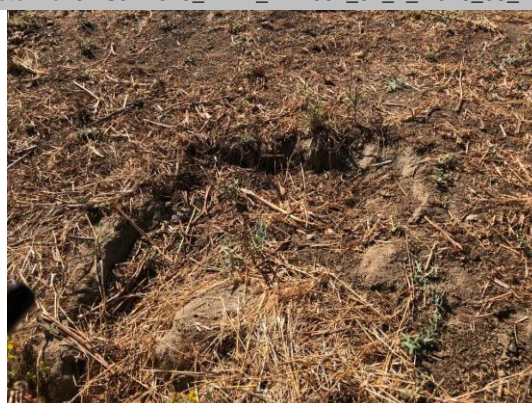
Photo 2 of 3 : SJR2019_DWR_RD1602_01_f _ 2018_98_2.JPG

Close view of the largest erosion pocket.

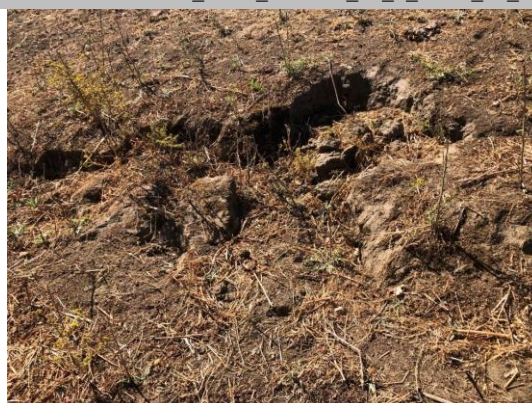
Photo 3 of 3 : SJR2019_DWR_RD1602_01_f _ 2018_98_3.JPG

Close-up view of the erosion.

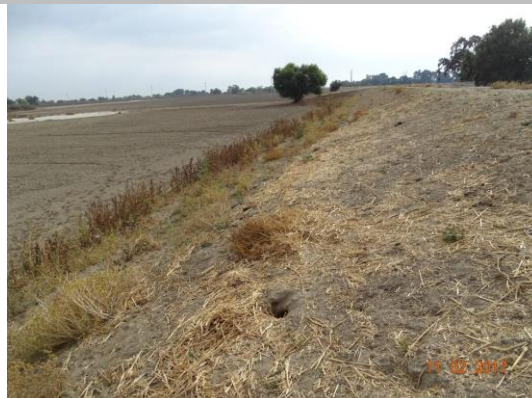
Photo 1 of 1 : FA_2019_RD1602_110_51_20190912_00025.jpg

View of a rodent hole on the waterside of the levee.

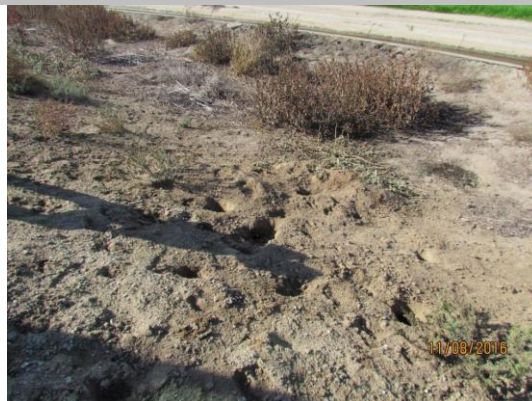
Photo 1 of 1 : FA_2019_RD1602_110_56_20190912_00027.jpg

View of rodent holes on the landside of the levee. Fall 2016

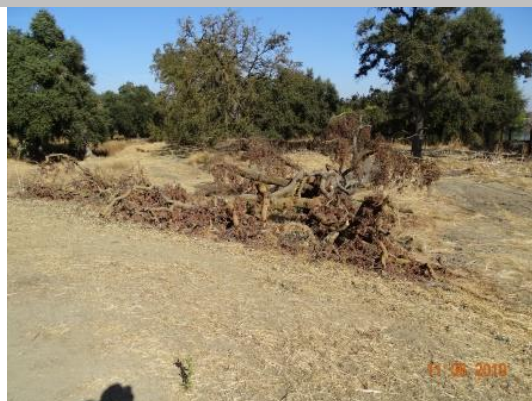
Photo 1 of 1 : FA_2019_RD1602_110_102_20191114_00120.jpg

View of fallen tree on the waterside slope and toe. (Fall 2019)

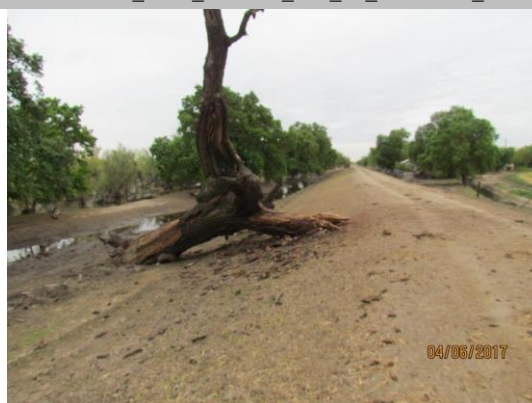
Photo 1 of 1 : FA_2019_RD1602_110_83_20190912_00048.jpg

View of a tree trunk on the waterside slope of the levee.

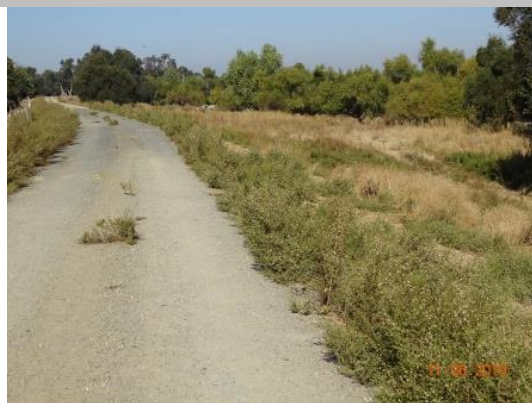
Photo 1 of 1 : FA_2019_RD1602_110_100_20191114_00121.jpg

View of the waterside slope looking downstream. (Fall 2019)

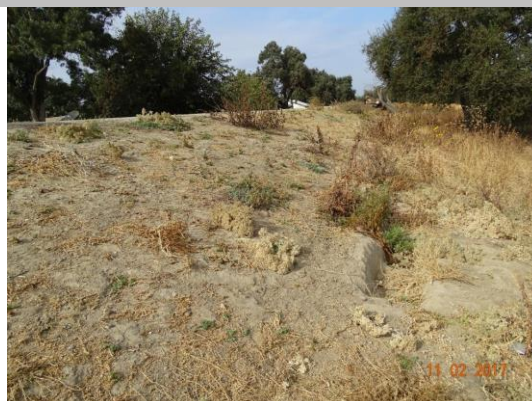
Photo 1 of 1 : FA_2019_RD1602_110_84_20190912_00049.jpg

View of rodent holes on the waterside of the levee.

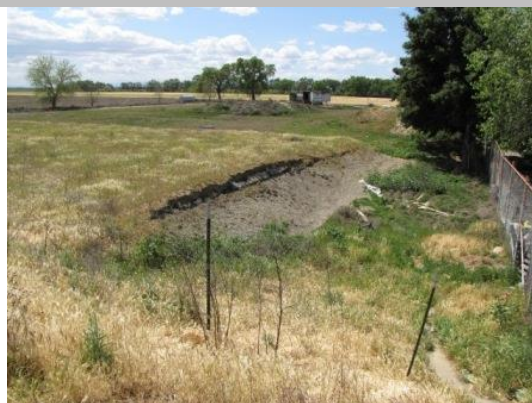
Photo 1 of 1 : FA_2019_RD1602_110_62_20190912_00032.jpg

LM Start	3.93	Rating **	M	Issue No.	62
LM End	3.93	Issue Type +	Ma	Location *	LS
Category	Earthen Levee			GPS Latitude/Longitude	
				Start	End
Item	Slope Stability			37.453216 °	37.453216 °
				-121.042127 °	-121.042127 °
DWR ID	DWR_RD1602_01_s_2012_62				
Comment Code					
S3 : Repair the levee slope damaged by vehicle traffic and prevent access where possible.					
Inspector Comment					
Significant damage to USACE constructed seepage berm due to human activity.

Repair damage to USACE constructed seepage berm by pedestrian and cycle traffic.

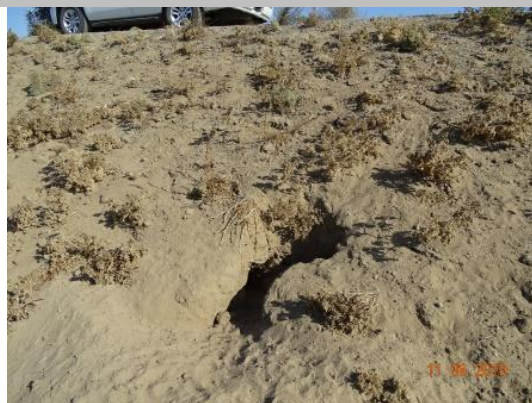
Photo 1 of 2 : FA_2019_RD1602_110_87_20191114_00122.jpg

View of rodent burrows in the landside slope. (Fall 2019)

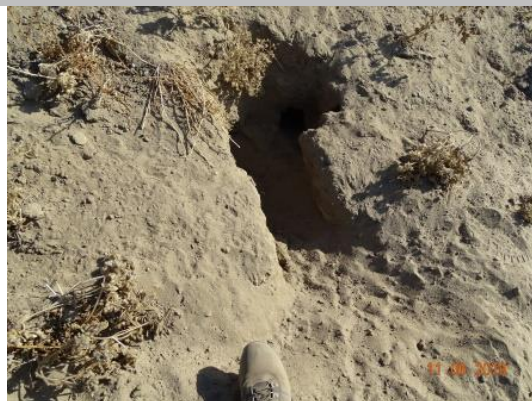
Photo 2 of 2 : FA_2019_RD1602_110_87_20191114_00123.jpg

Representative rodent burrow in the landside slope. (Fall 2019)

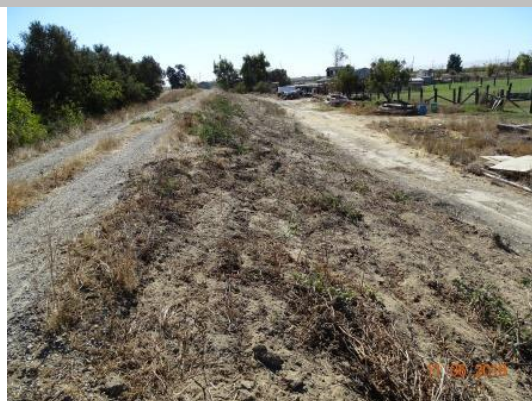
Photo 1 of 2 : FA_2019_RD1602_110_89_20190912_00051.jpg

LM Start	5.08	Rating **	M	Issue No.	89	
LM End	5.13	Issue Type +	Ma	Location *	LS	
Category	Earthen Levee			GPS Latitude/Longitude		
				Start		End
Item	Slope Stability			37.438249 °		°
				-121.037100 °		°
DWR ID	DWR_RD1602_01_f_2018_89					
Comment Code						
S3 : Repair the levee slope damaged by vehicle traffic and prevent access where possible.						
Inspector Comment						
Damage to slope appears to be from vehicle traffic.

View along landside slope looking upstream. (Fall 2018)

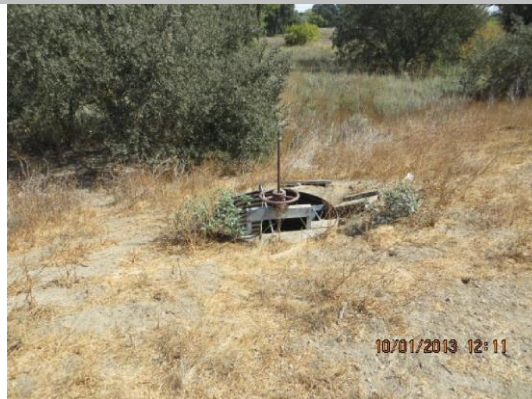
Photo 1 of 3 : UCIP_FA_2019_51336_36822.jpg

Comment Code						
Inspector Comment						
DS_ID:20208 FS_ID:51336 EP_NO: N/A Repair Type: Non-Urgent Crossing Status: Found UCIP Comments: 11/18/2016 Same as previous inspection soil and debris prevent flap gate from properly functioning and slide gate won't close due to sediment build up. Crossing has been downgraded from Urgent to Non-Urgent due to no pipe or levee integrity issues observed during the site visit. Need to contact owner to determine status of crossing. If crossing is no longer in use owner will need to coordinate with CVFPB to properly abandon or remove according to Title 23 requirements. (O. Magana - DWR UCIP)10/01/2013 Soil and debris prevent flapgate from proper function. Slide gate won't close completely due to sediment buildup. CMP riser needs cover. (W. Wylie - DWR UCIP) FIELD_STRUCT_DESC: 24-inch steel pipe through levee, 11.6 feet below crown. Concrete headwall on the landside (LS) end. Concrete "U" headwall and flap gate located on the waterside (WS) end. Slide gate in 60-inch corrugated metal pipe (CMP) riser is located on the WS slope. [Additional Reference(s): DWR Levee Log, 1992. USACE San Joaquin River O&M Manual Unit 13, April 1964, (HLM 5.23), Drawing No. 7-4-1784]. FS Date: 11/18/2016

Slide gate in CMP riser on WS slope. Outlet visible under tree in background.

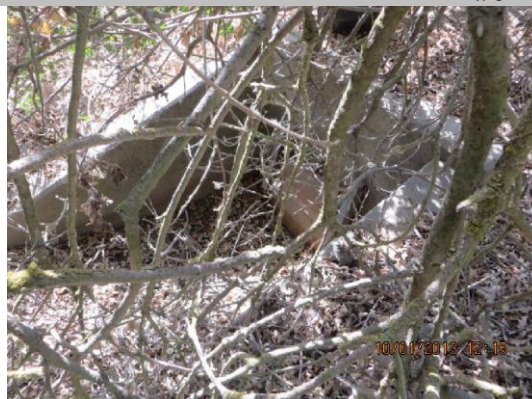
Photo 2 of 3 : UCIP_FA_2019_51336_36821.jpg

Flapgate in Concrete headwall on WS toe under tree.

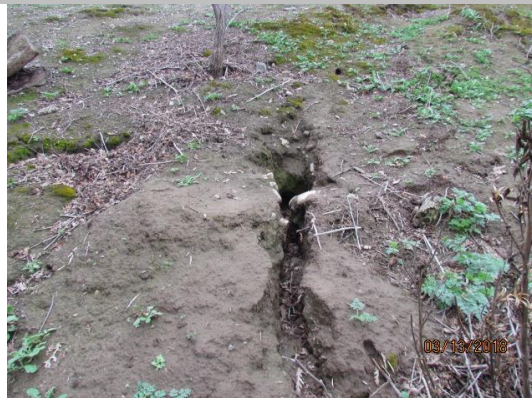
Photo 1 of 1 : FA_2019_RD1602_110_52_20190912_00026.jpg

Looking at rodent hole and erosion around rodent hole on waterward slope.

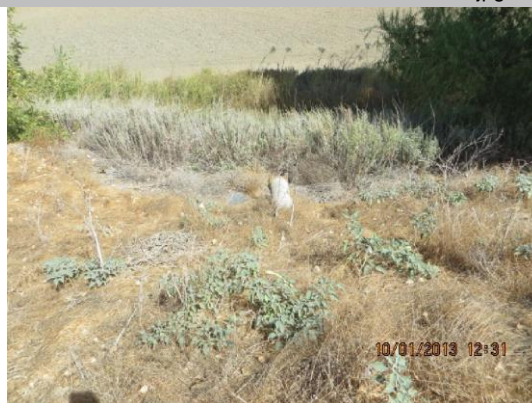
Photo 1 of 1 : UCIP_FA_2019_21674_36854.jpg

Pipe and flapgate visible on WS toe.

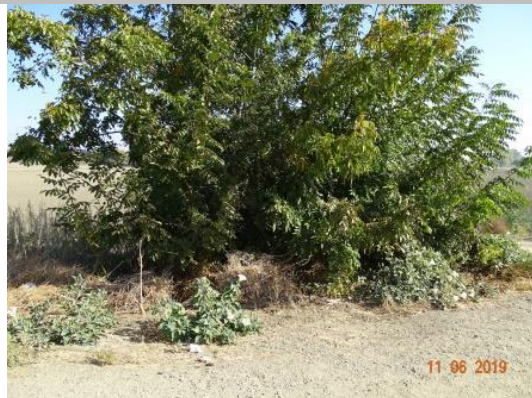
Photo 1 of 1 : FA_2019_RD1602_110_38_20191114_00130.jpg

View of a tree growing on the waterside slope. (Fall 2019)
